Preliminary Assessment Report
*1-7, 13, 15, 16 Fourth Street and 209 Valley
Street
South Orange, New Jersey*

April 2015

Fennelly Environmental Associates, LLC
116 Village Boulevard, Suite 200
Princeton, New Jersey 08540

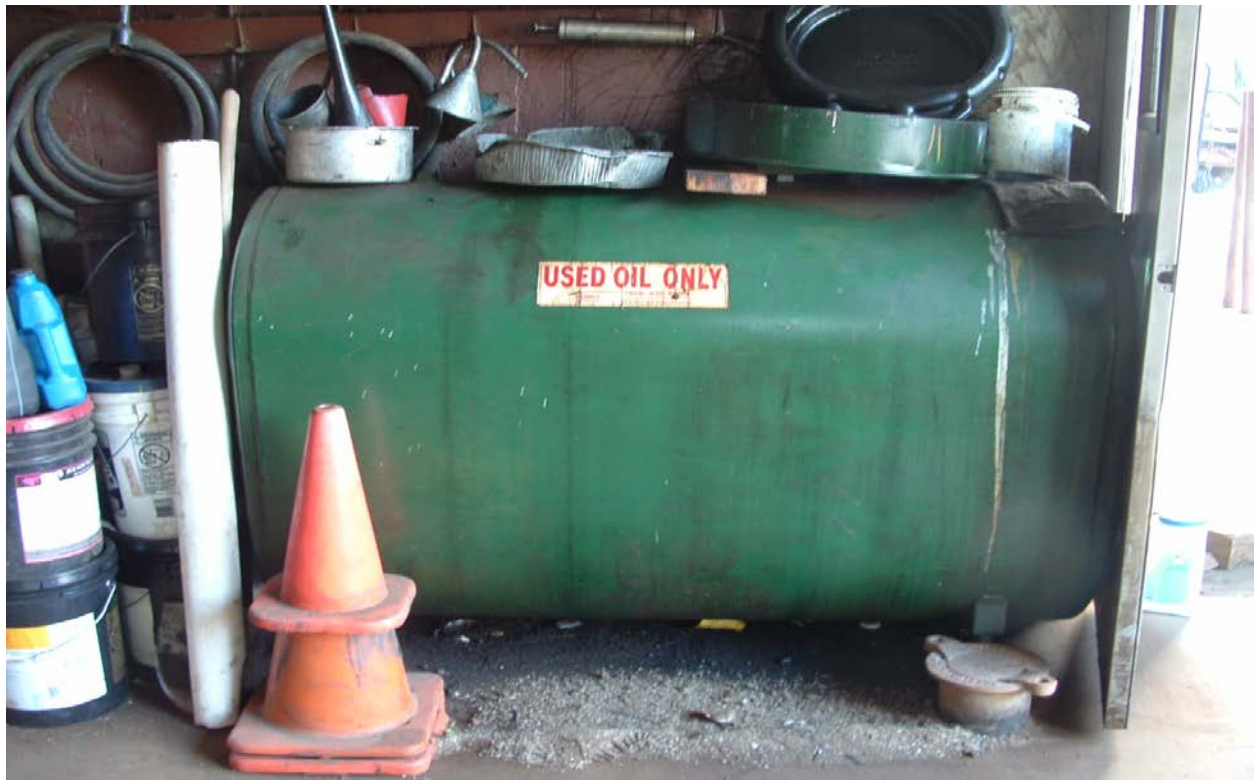
The subject property at 13 Fourth Street has been mainly used for residential purposes. Household cleaning supplies were stored throughout the living space. One 275-gallon used oil tank was located in the garage space. Used oil is recovered and recycled by Lorco. Some staining was observed on the floor under this AST.

Photo 1 AOC-1 - 275-gallon used oil AST at 13 Fourth Street

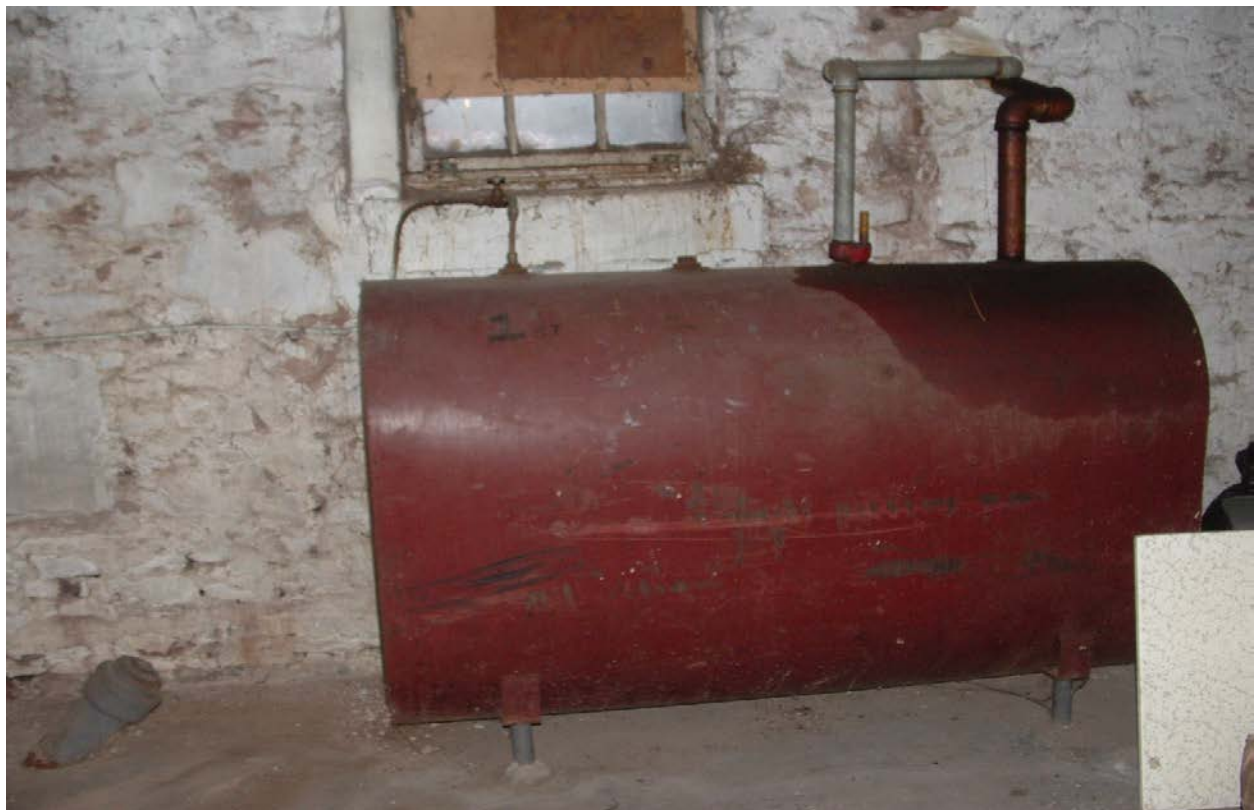
The subject property at 15 Fourth Street has been mainly used for residential purposes, however, a family owned concrete and construction company was once run out of the home. One empty diesel fuel AST was observed in the garage/storage area. This AST was taken out of service ~35 years ago, but the empty tank still remains onsite. Some staining was observed on the ends of the tank at the bottom. The area where the tank used to sit was partially snow covered and wet, therefore, it was difficult to determine any staining on the asphalt. No other chemicals were observed onsite.

Photo 2 AOC-1 - 275-gallon heating oil AST at 15 Fourth Street

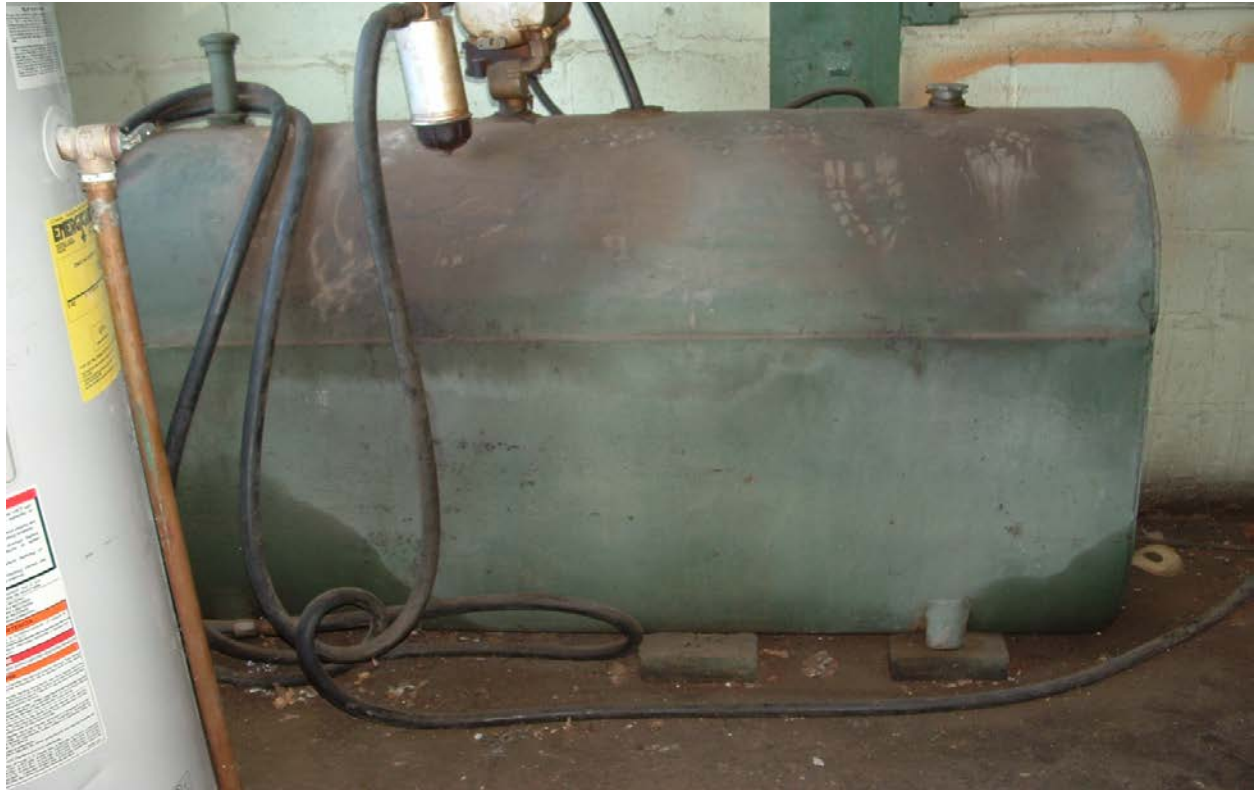
The subject property at 16 Fourth Street has been mainly used for residential purposes. Household cleaning chemicals and detergents were stored in various places throughout the home. Currently, one 275-gallon heating oil AST services the first floor of the residence and was located in the basement. Spillage/overflow stains were observed on the top and sides of the tank, but no stains were observed on the floor underneath the tank. A second heating oil AST was removed from the basement in 2014. No staining was observed in the area of the former AST.

Photo 3 AOC-1 - 275-gallon diesel fuel AST at 16 Fourth Street

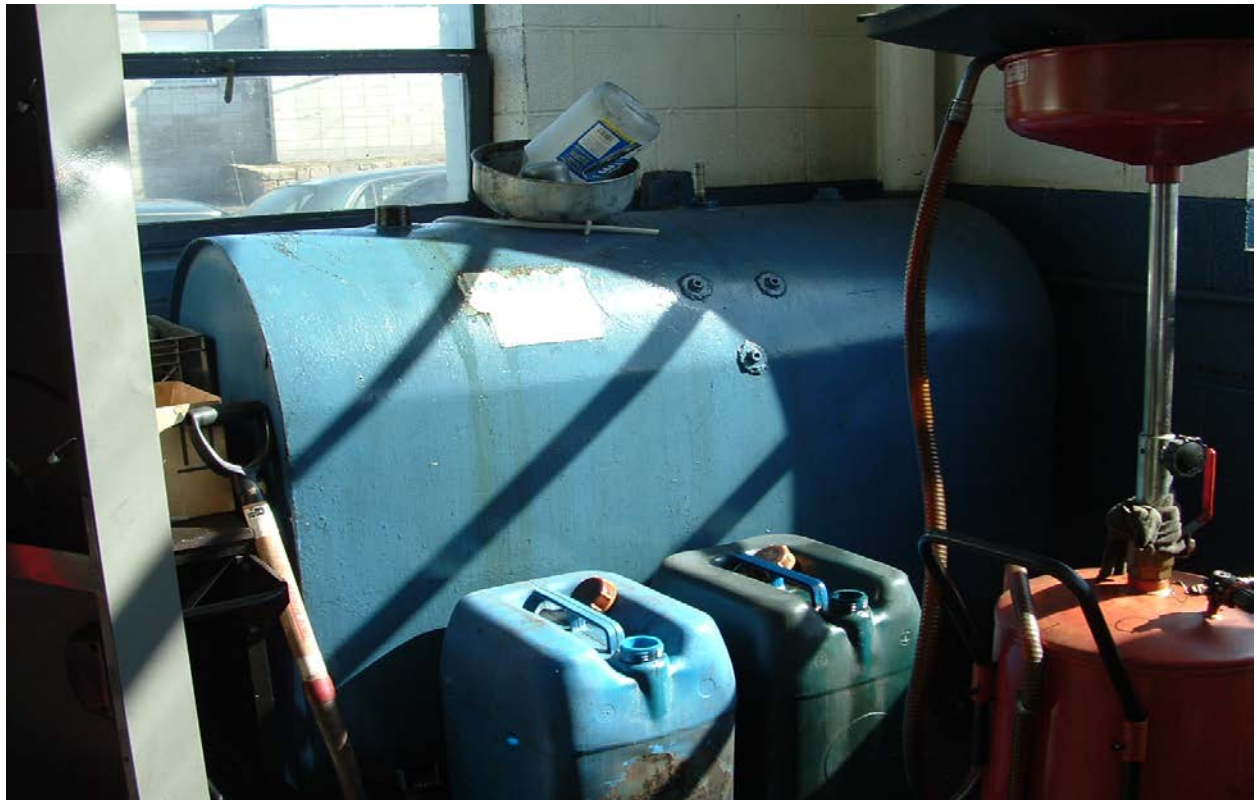
- AOC-1 Aboveground Storage Tanks (ASTs) – One 275-gallon waste oil tank and a 500+ gallon motor oil tank are located within the automobile repair shop. Both tanks are situated on a concrete floor that is set above a full basement area. No staining or obvious signs of overfilling were observed by these tanks, and there is no direct migratory pathway in which spilled oil could impact the underlying soil.
- AOC-2 USTs – Identifies USTs that were abandoned in place and removed and covered under the March 2000 NFA.

Photo 4 AOC-1 - 275-gallon used oil AST at 209 Valley Street

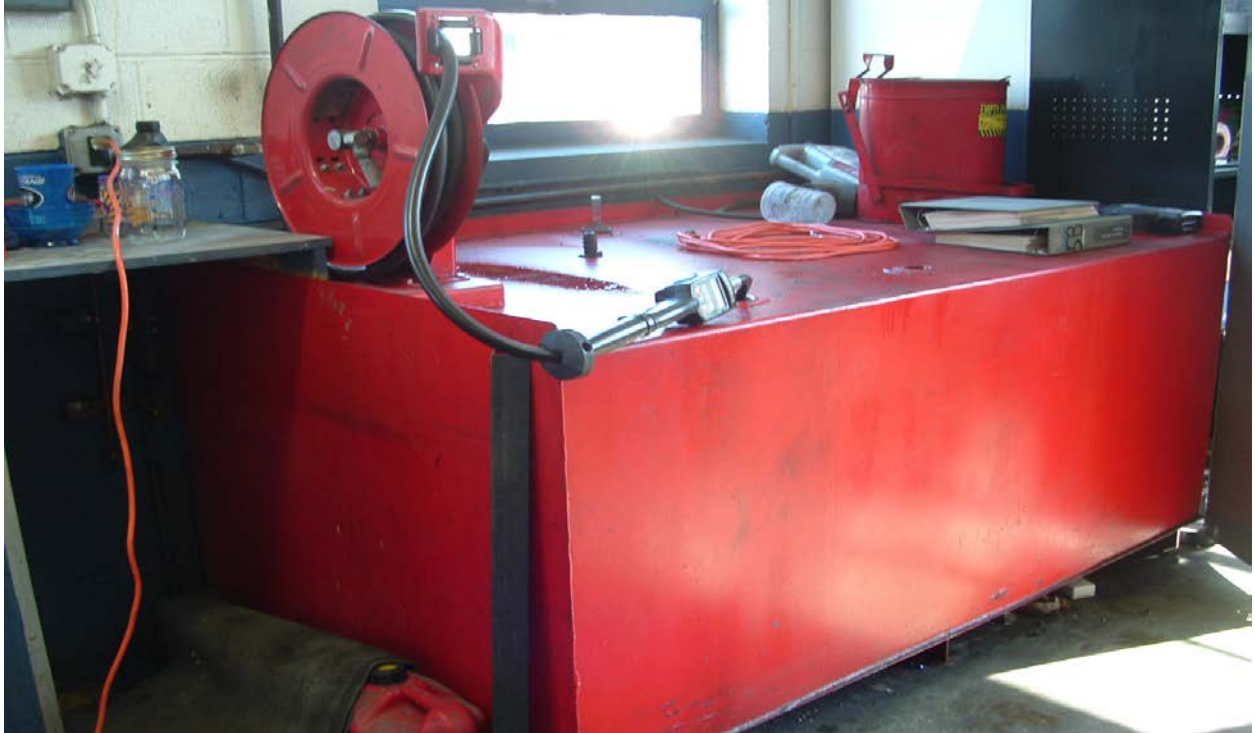
Photo 5 AOC-1 - 500+gallon motor oil AST at 209 Valley Street

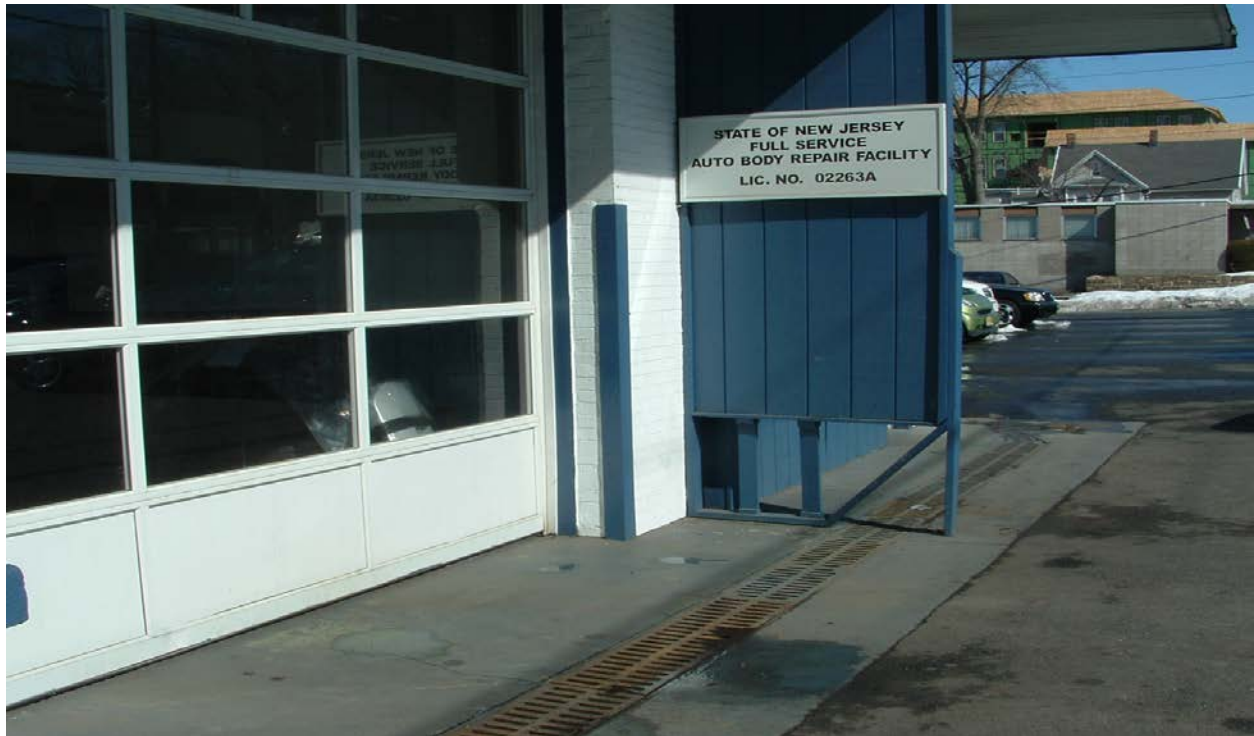
Currently, sanitary discharges from 209 Valley Street are also directed to the municipal sanitary sewer system. Floor drains were observed on the ground floor of the auto body shop within central portion of the building. An active curtain drain was observed in front of the garage door to the main service area, and cement-sealed curtain drains were observed within the auto body shop. An active curtain drain was also observed within the basement, which are apparently connected to the municipal sewer. No staining was observed around any of these floor drains.

Photo 7 AOC-3 Curtain Drain at 209 Valley Street

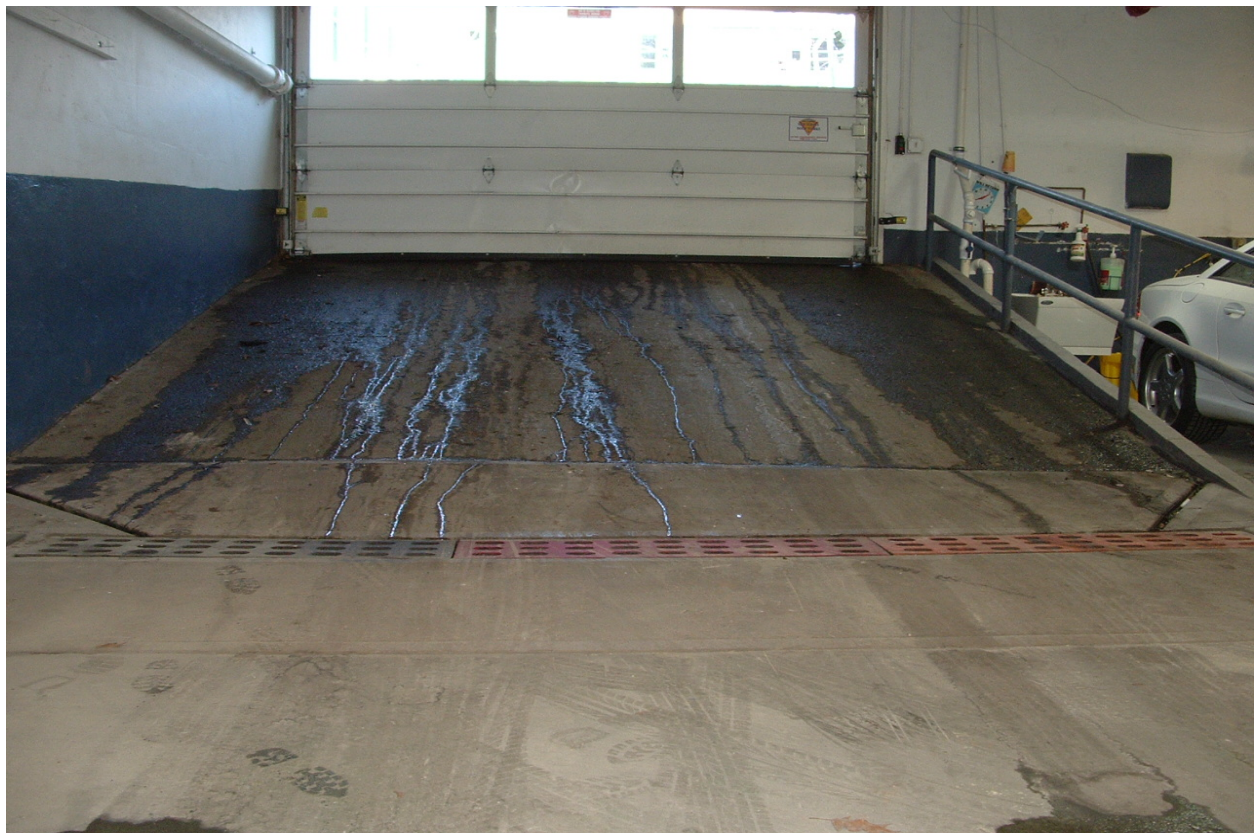
- AOC-5 Floor Drains – Floor drains were observed in the ground floor of the body shop. No staining was observed by these floor drains. A curtain drain was observed in front of the garage door to the main service area, and cement-filled curtain drains were observed within the auto body shop. A curtain drain and sump pump were also observed within the basement, which is connected to the municipal sewer.

Photo 8 AOC-3 - Curtain Drain in basement at 209 Valley Street

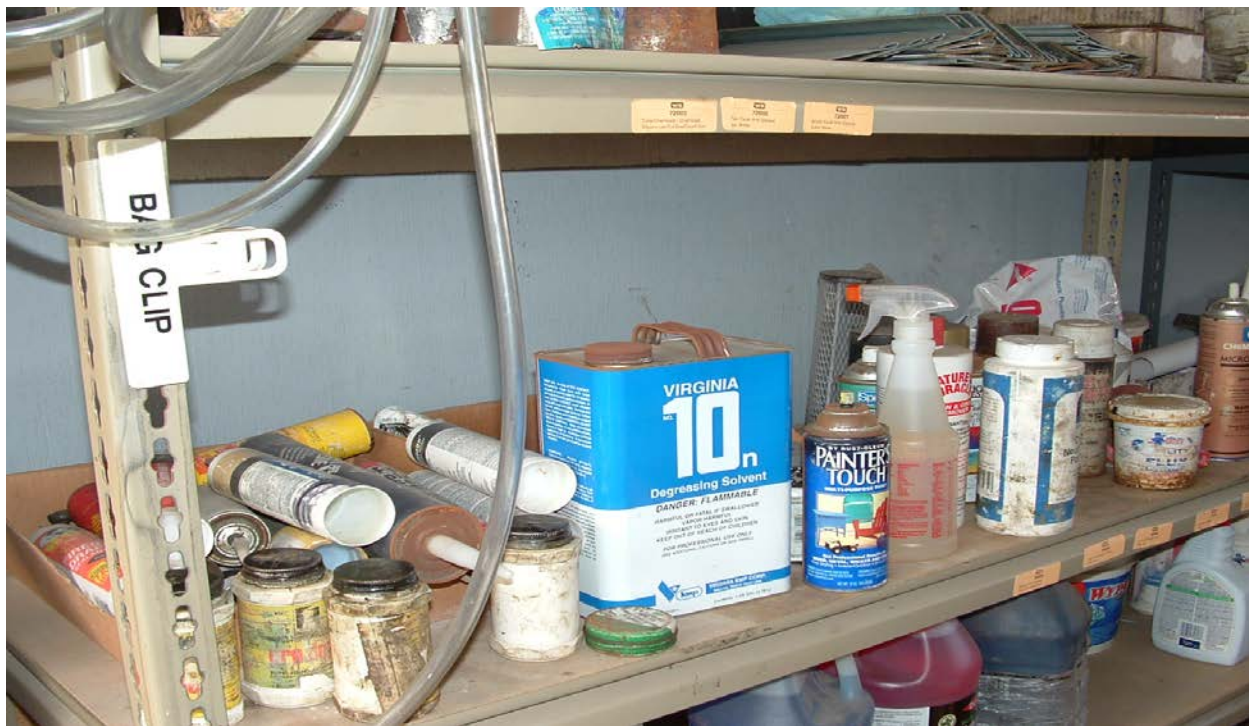
Photo 9 AOC-4 - Chemical Storage Area at 1-7 Fourth Street

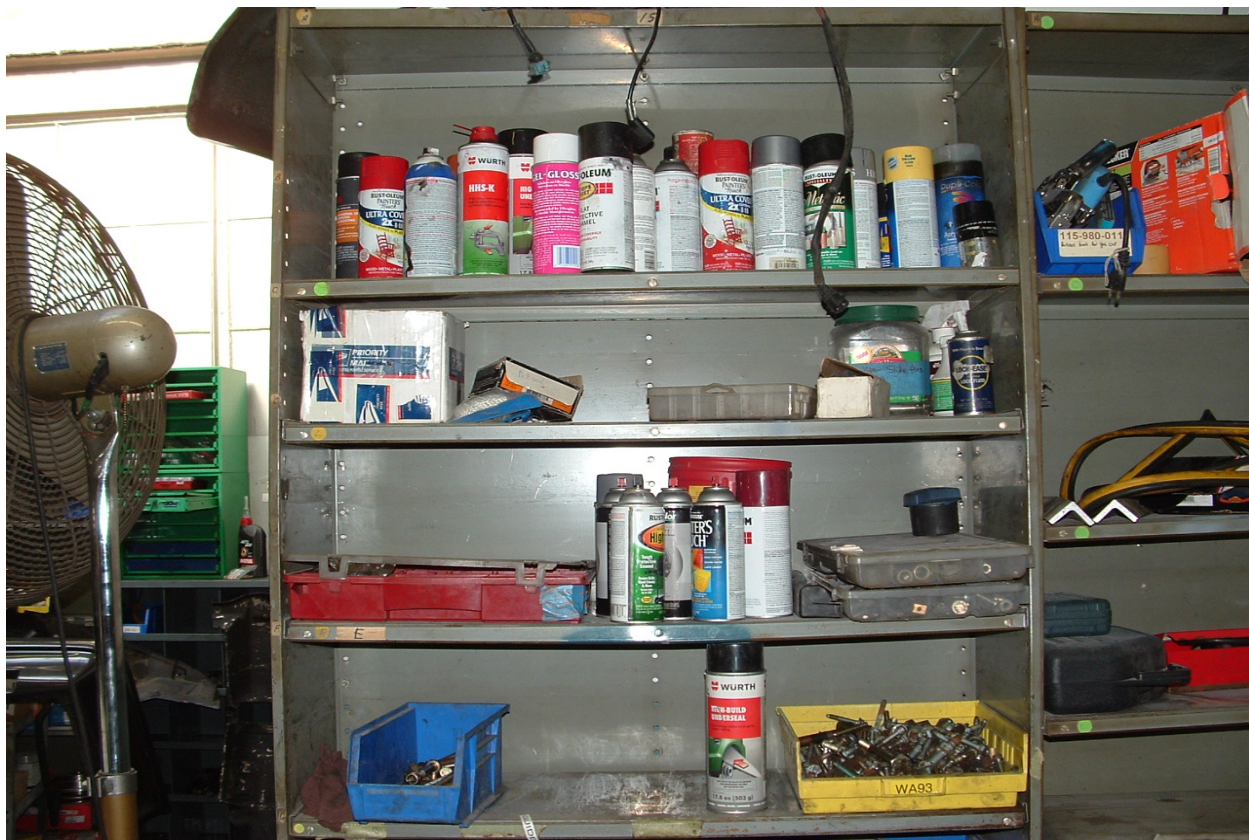
- AOC-4 Chemical Storage Closets – small quantities of commercially packaged paints and solvents are used in the spray booth by Beifus Motors. Paints are stored and mixed in the paint mixing room behind the spray booth. Spent paints are drummed for off-site disposal, and there is a Safety Kleen™ solvent recovery system located adjacent to the spray booth to collect spent paint solvents. No significant staining was observed in the paint mixing room, and it appears paints and solvents are properly handled.

Photo 10 AOC-4 - Chemical Storage Area at 209 Valley Street

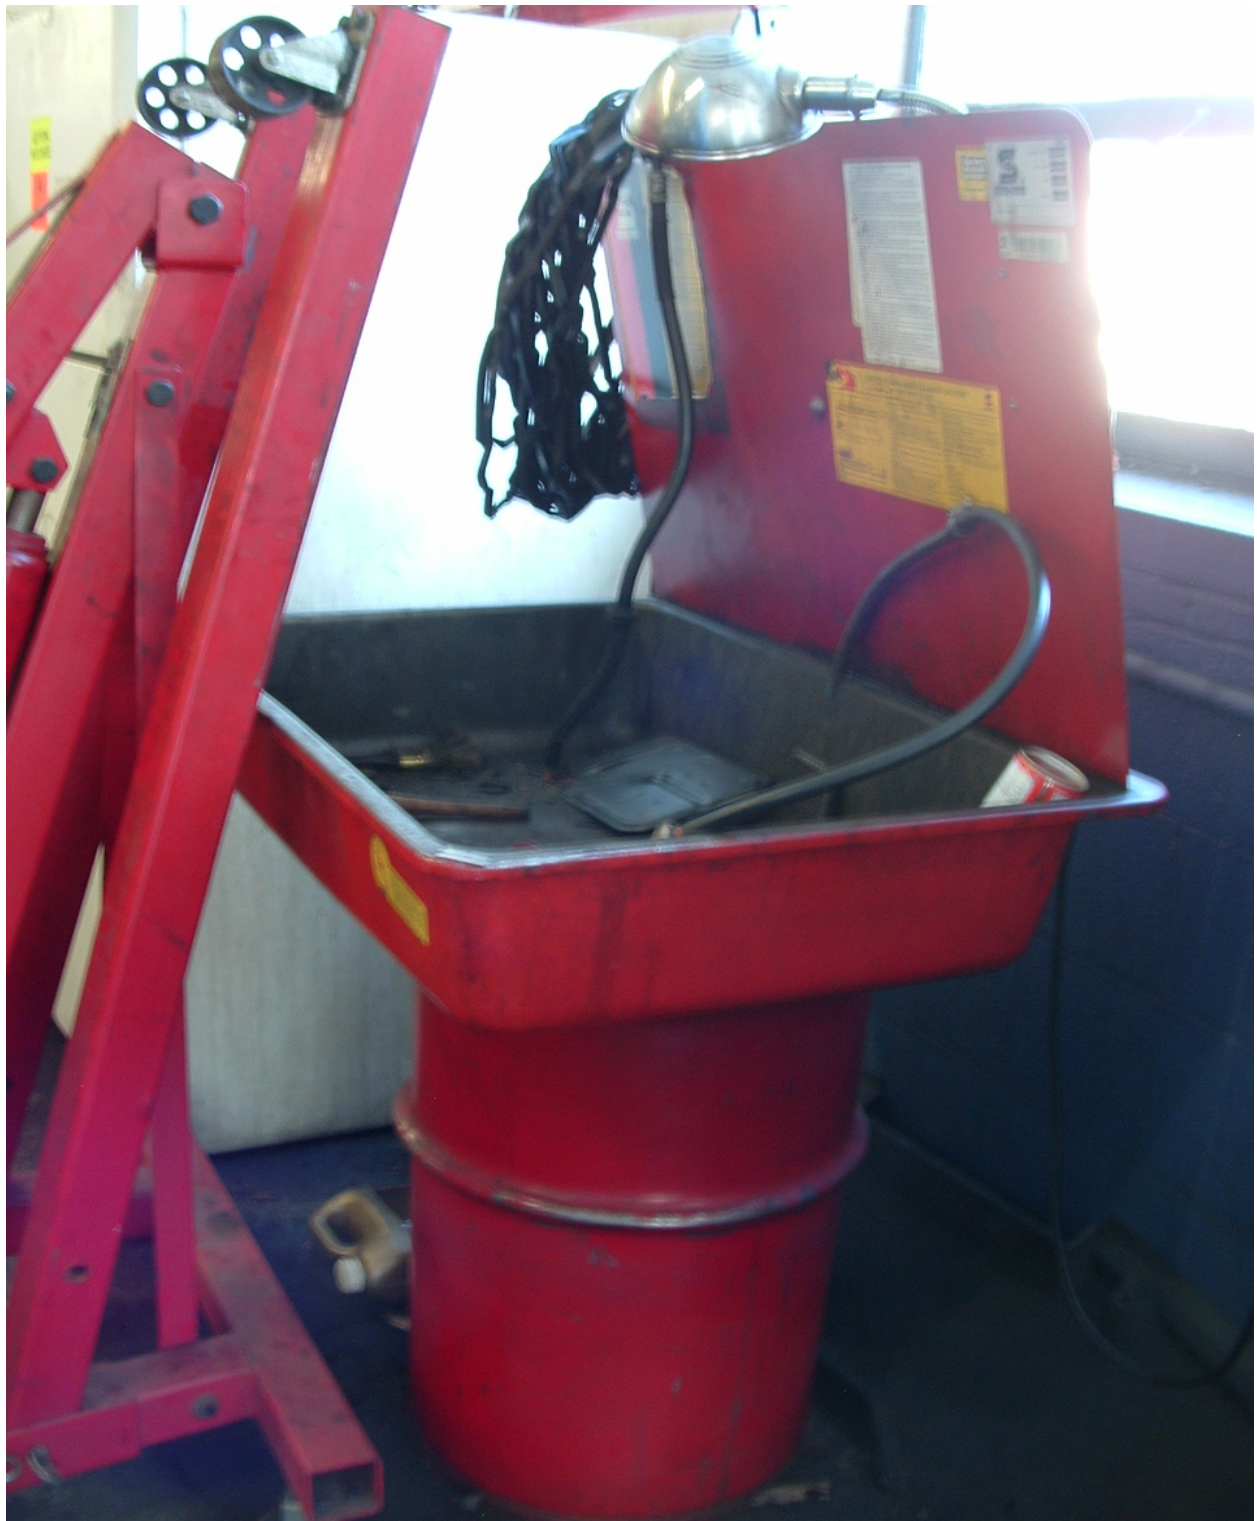
Photo 11 AOC-5 Parts washing sink at 209 Valley Street

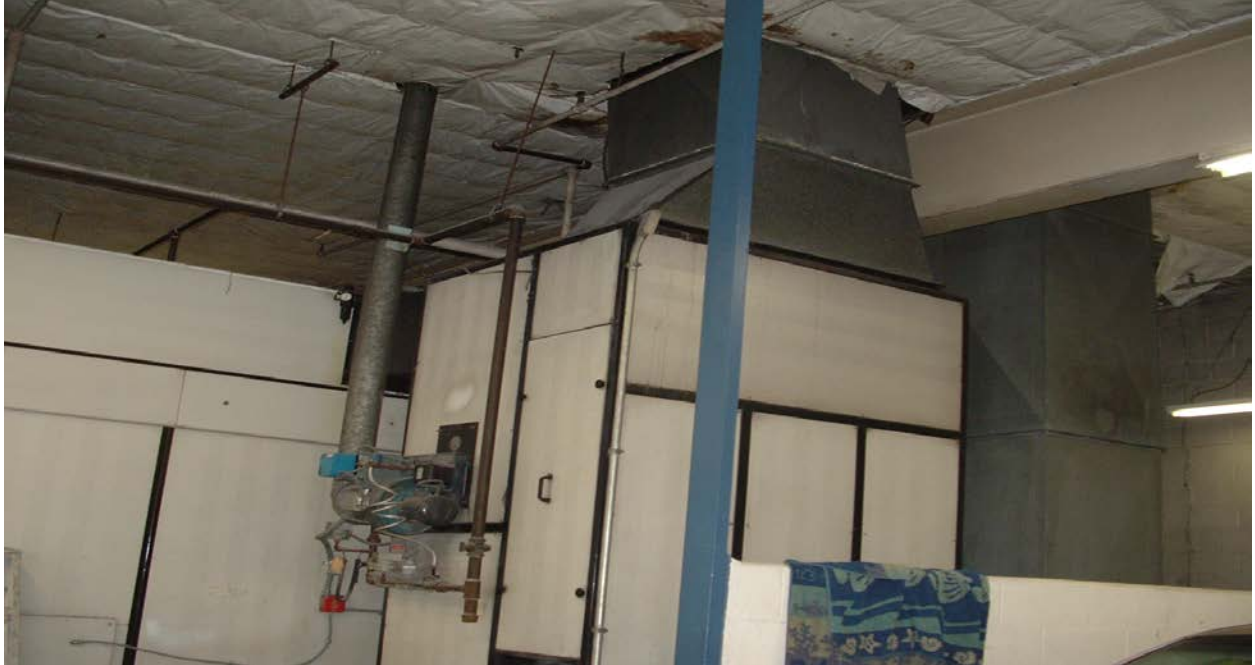
Photo 12 AOC-6 - Spray Booth exhaust system at 209 Valley Street

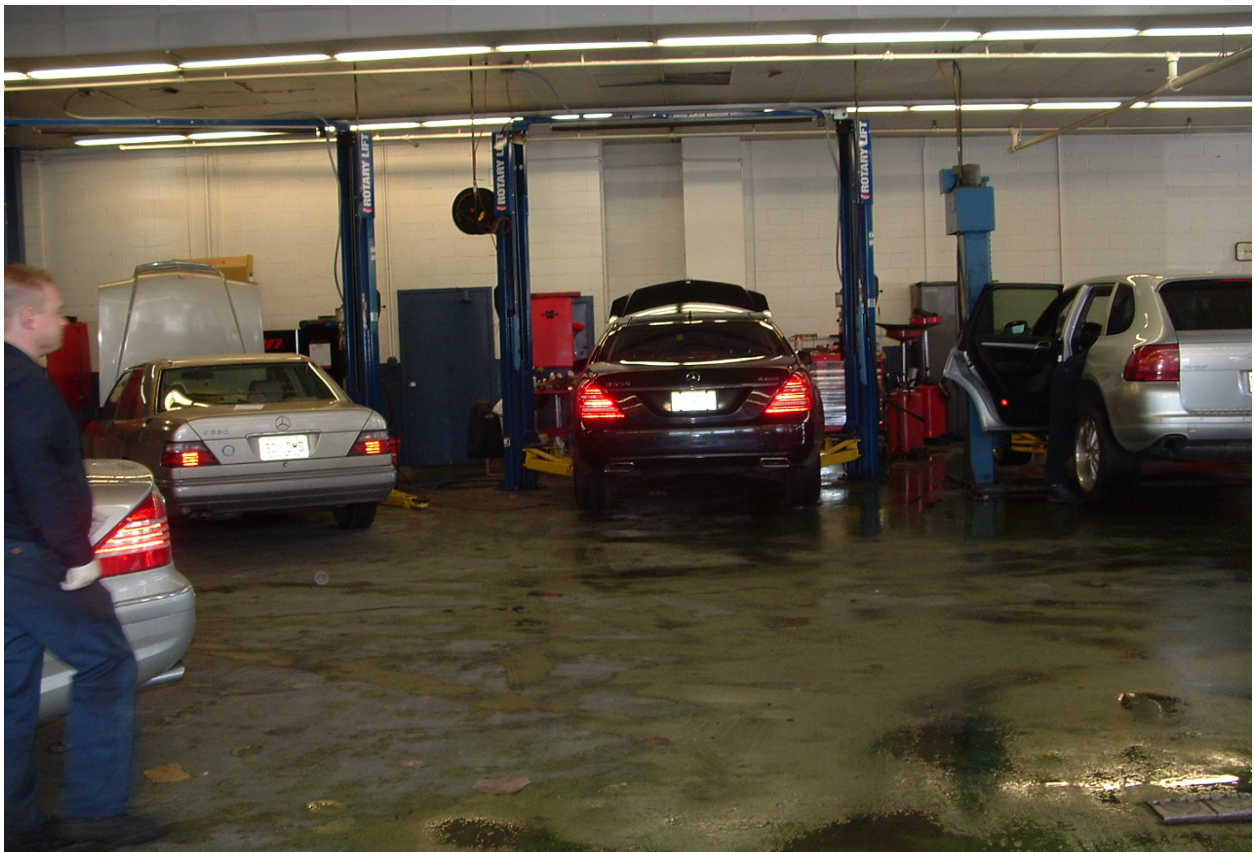
Photo 13 AOC-7 - Hydraulic Lifts at 209 Valley Street

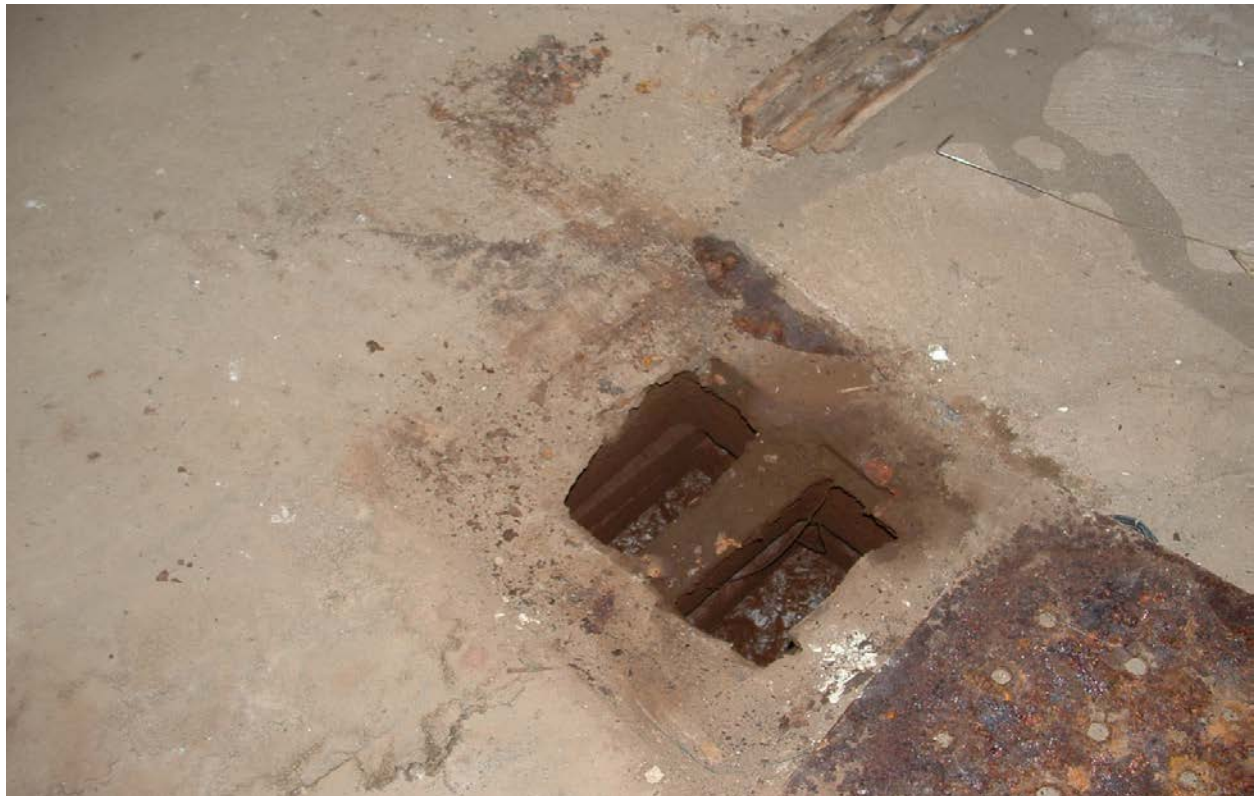
the AST is recycled by Lorco in machines that use this type of oil. This area was formerly used for maintenance and repairs of vehicles related to the family's construction business (South Orange Contracting Company). Mr. Iantosca did mention that two 1,000-gallon USTs were removed from the subject property in late 1999 to early 2000, and he was not aware of any spills, discharges or releases at the subject property. A dry well was also present in the basement.

Photo 15 AOC-9 - Dry Well at 13 Fourth Street
